IV. Analysis of Existing Conditions

The South Capitol Gateway and Corridor Improvement Study began with the *Existing Conditions Analysis*, completed in early 2003. This document includes technical data that underscores the need to make fundamental changes to South Capitol Street's transportation infrastructure.

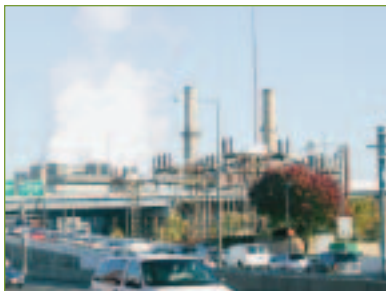
Abandoned substation from the Pennsylvania Railroad near the intersection of South Capitol and Eye Streets SE

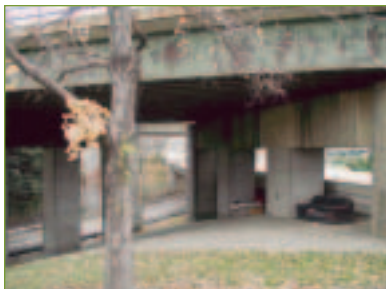
View underneath Southeast Freeway's elevated ramps

South of the U.S. Capitol, elevated railroad tracks and the Southeast-Southwest Freeway create a barrier that separates Capitol Hill from the city to the south. South Capitol Street's interchange with the Southeast-Southwest Freeway is a tangle of highway ramps that bracket the street, interrupting the sidewalks and obstructing access to nearby neighborhoods.

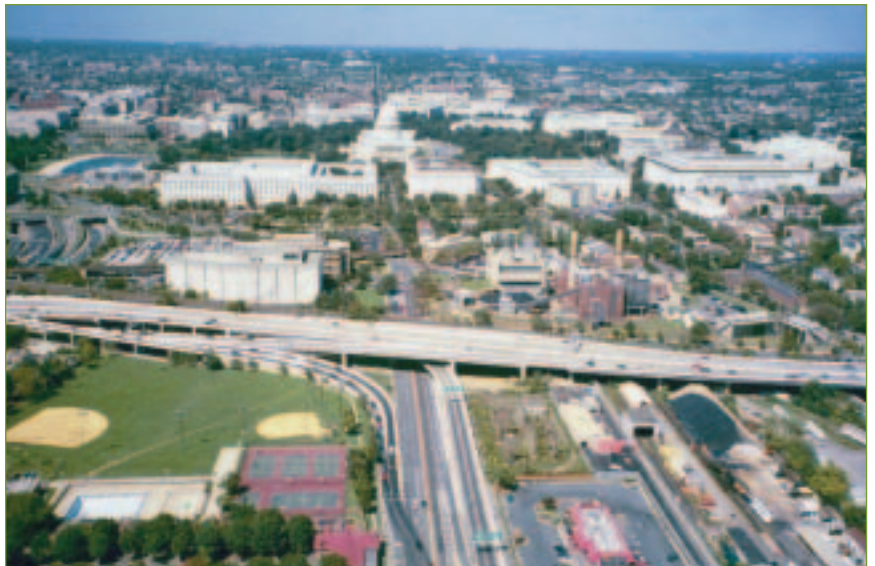
South Capitol Street and Southeast Freeway with U.S. Capitol to the north

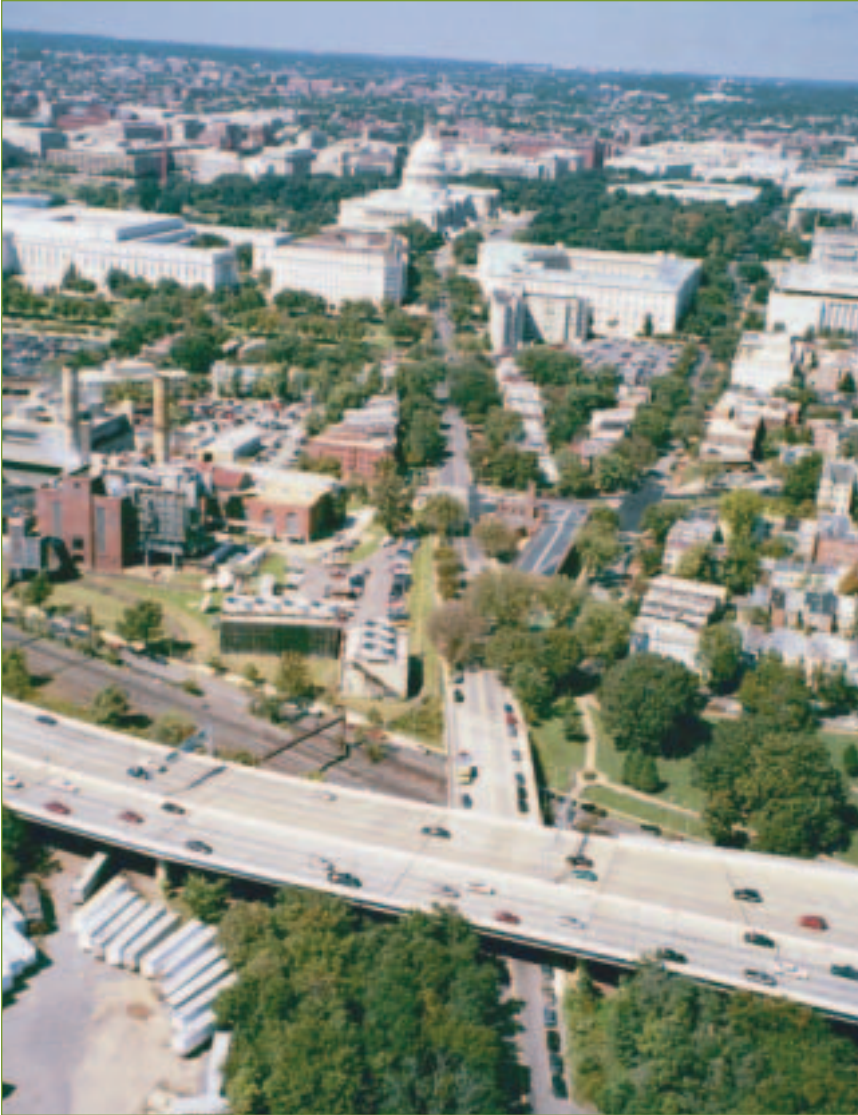
New Jersey Avenue SE and Southeast Freeway

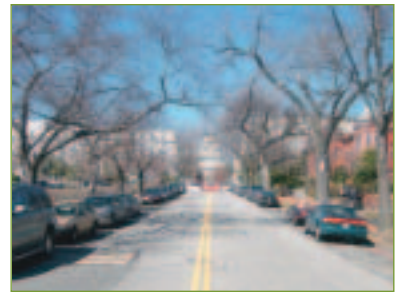
New Jersey Avenue SE north of Southeast Freeway

The bleak condition of South Capitol Street is paralleled by that of New Jersey Avenue SE. Although one block near the Capitol is lined with trees and handsome Victorian rowhouses fronted with wrought-iron fences, most of the avenue is dominated by parking lots and abandoned buildings.

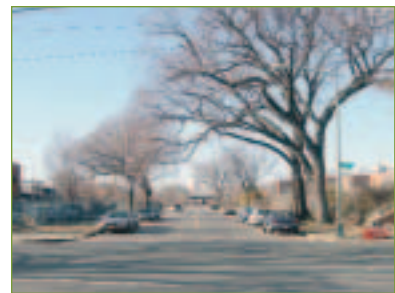
New Jersey Avenue SE south of Southeast Freeway

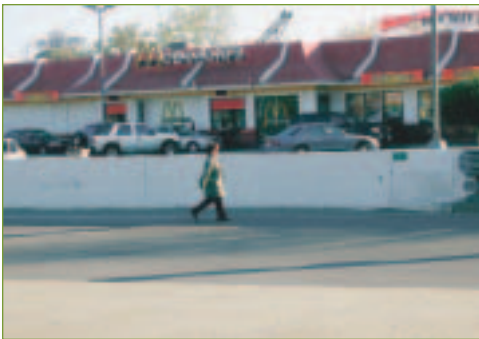
Pedestrian walking along South Capitol Street near Eye Street SE

Eye Street is the first local street that crosses South Capitol Street south of the freeway. The freeway ramps make this intersection complex. Southbound traffic from the freeway encounters a traffic signal and a right-turn-only lane. Northbound traffic must weave across several lanes to reach the freeway ramps. Because of this complexity, this intersection is congested during peak traffic periods. Inadequate signs and narrow lanes contribute to the hazards at this intersection, which is ranked the ninth worst in the District because of its high number of right-angle and rear-end collisions.

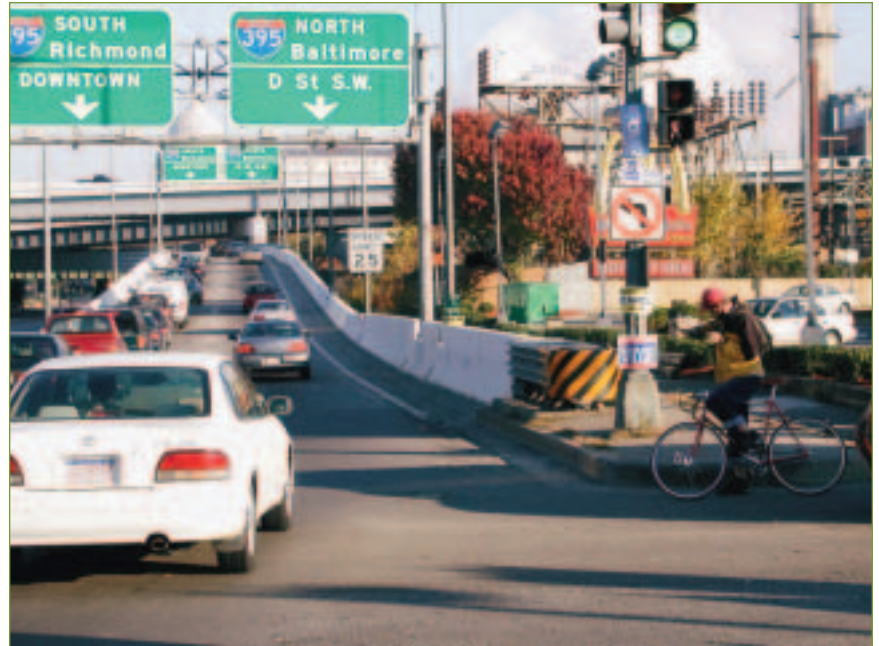
Cyclist attempting to turn onto South Capitol Street from Eye Street SE

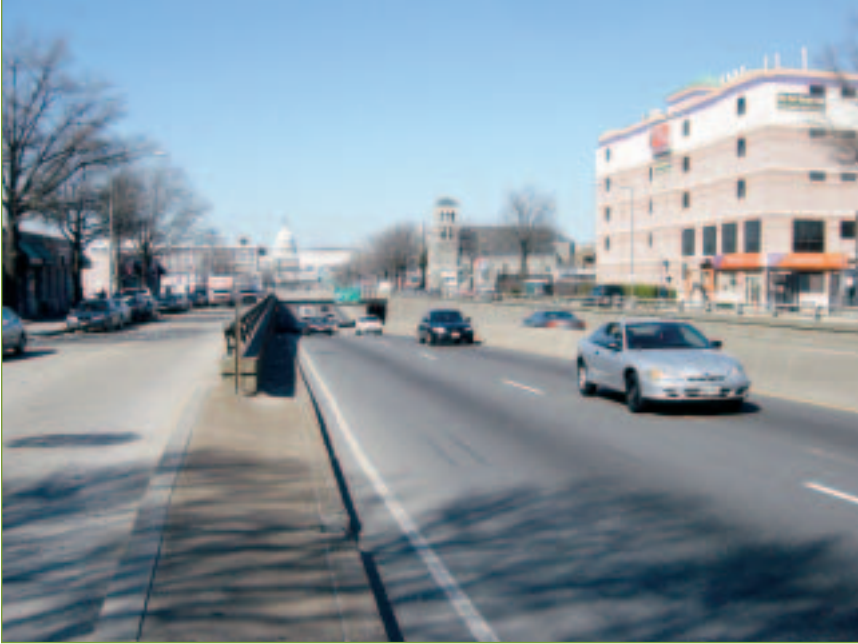
South Capitol's underpass below the intersection at M Street

Although traffic that merges from the Southeast-Southwest Freeway is brought to an abrupt halt at Eye Street, it is immediately encouraged to accelerate as South Capitol Street approaches M Street and dips beneath it. High volumes of turning traffic and short sight distances contribute to this intersection's ranking as the 18th worst accident location in the District of Columbia.

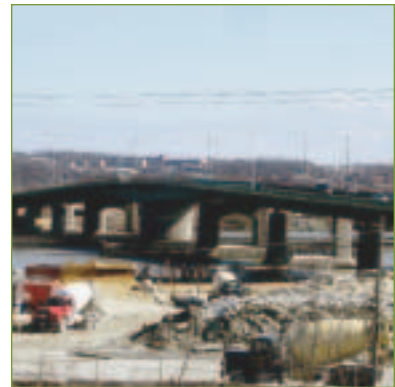
Concrete plant east of South Capitol Street along the Anacostia River

Present land use along South Capitol Street is mostly commercial. Warehouses, gas stations, fast-food restaurants, and a few small businesses line the blocks between the Southeast-Southwest Freeway and the Anacostia River. South of Potomac Avenue, land is either used for industrial purposes or vacant.

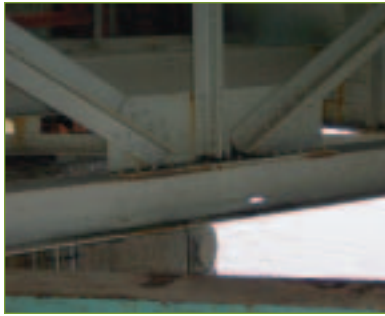
Frederick Douglass Memorial Bridge steel section loss

The bridge is in poor structural condition and will soon require replacement. The District Department of Transportation plans to carry out critical safety-related rehabilitation and preventive maintenance to extend its life approximately fifteen years.

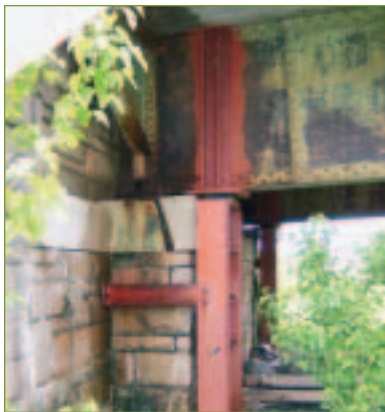
Frederick Douglass Memorial Bridge failed bearing plate at southeast abutment

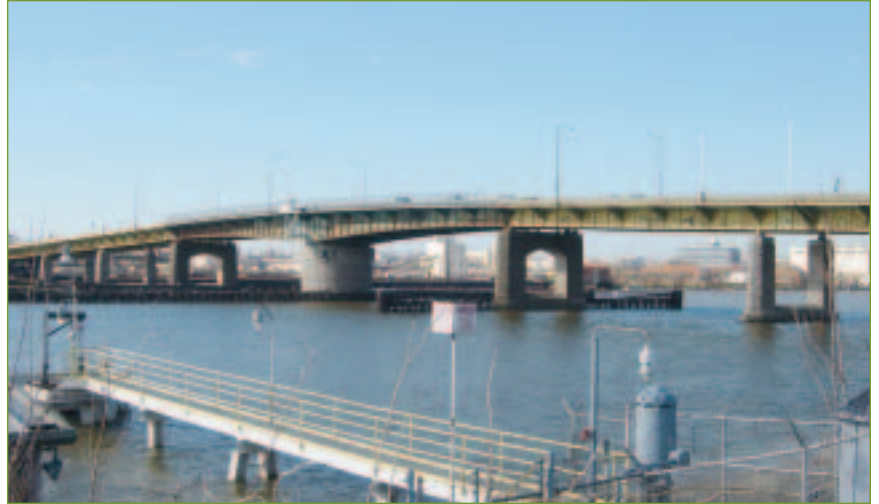
Frederick Douglass Memorial Bridge looking toward the Navy Yard from the east of the Anacostia River

The Frederick Douglass Memorial Bridge is a utilitarian structure with little architectural or historic merit. The odd number of traffic lanes—three inbound and two outbound—are the result of a 1975 widening. Pedestrians and bicyclists share the narrow walkways on both sides. The center span of the bridge swings open to allow river traffic to pass.

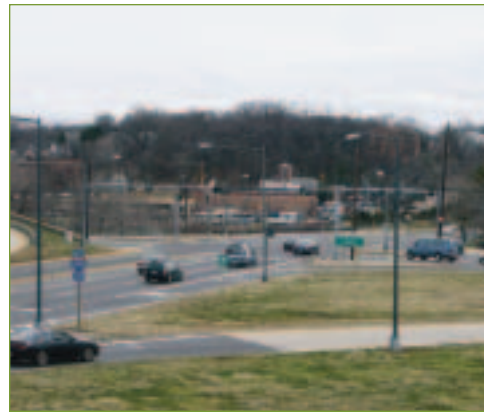
Intersection at Firth Sterling Avenue and Martin Luther King, Jr. Avenue, which has the highest fatality rate in the District of Columbia

Two streets, Firth Sterling Avenue and Martin Luther King, Jr. Avenue, provide the only access across Suitland Parkway in this area. The intersection of the Suitland Parkway and Firth Sterling Avenue forces high-speed traffic from the parkway to stop. The sight distance for approaching traffic is short and signage is inadequate. These factors cause it to be the intersection with the 8th highest accident rate in the District. More importantly, it has the highest fatality rate of any District intersection. Rear-end accidents are the most common. Accidents involving pedestrians are especially frequent. Martin Luther King, Jr. Avenue is grade separated from the parkway, so it allows safe crossing but this intersection permits no access between the neighborhoods and the parkway.
